# LaCroix Davis, LLC

## PROJECT LOG

Client	<b>Department of General Services (DGS)</b>	Contractor: <b>JLS Environmental</b>	Day Swing <input checked="" type="checkbox"/> Weekend/Holiday
Project	<b>Board of Equalization (BOE)</b>	Location(s):	Floor 1 Floor 2 Floors
Address	<b>450 N Street Sacramento, CA 95814</b>		Mold <input checked="" type="checkbox"/>
			ACM <input type="checkbox"/> LBP <input type="checkbox"/>
			Other - Leak <input type="checkbox"/>
LCD Project #	<b>2372.02-572; SOW 5.0</b>	<b>Description:</b>	
LCD Project #	<b>2372.02-572; SOW 5.0</b>	<b>Description:</b>	
LCD Project #	<b>2372.02-572; SOW 4.0</b>	<b>Description: Floor 1, 2 Leak – Janitor Room</b>

# Water leak investigation - Janitor Room Floor 1 & 2

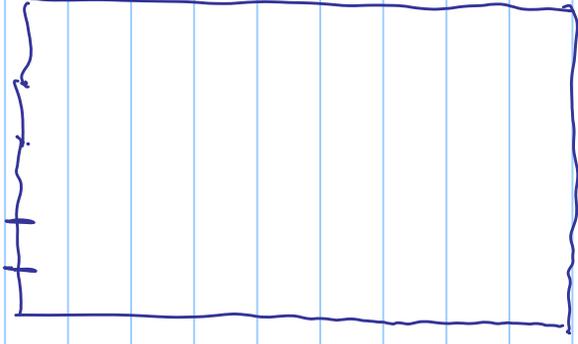
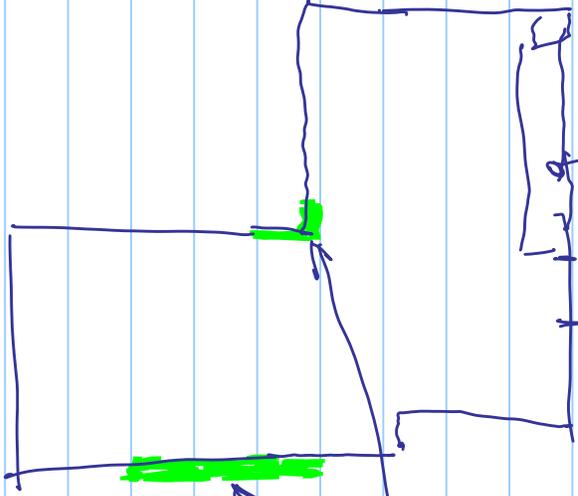
4B - VMG West wall at Cove base + Very stained + Capped floor  
at shelving

↑ MGS  
↑ remote 1st floor

↑ on 2nd floor

↑ damaged floor under cabinets

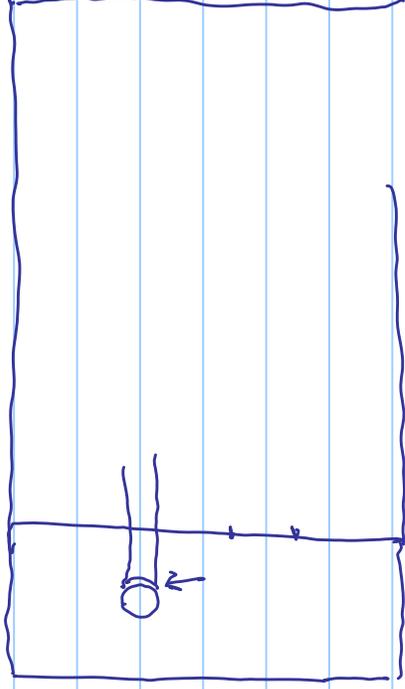
## 6 Janitor - Leak

Leak observed at Dom H<sub>2</sub>O riser at T to PRV  
JLS notified J. Armstrong - J. Beesley is coming  
to bldg to shut down dom H<sub>2</sub>O

discuss engineering controls w/ HT1 for pipe  
repair effort.

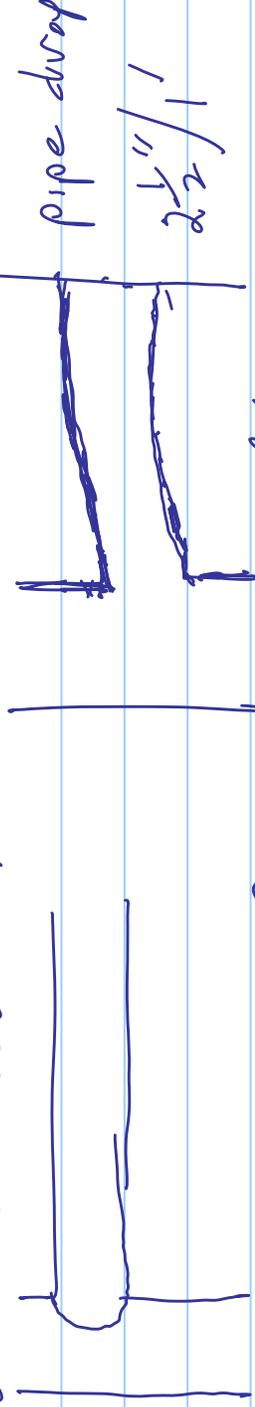
Repair completed Floor 6 janitor Room -  
Reactivate Domestic Water 14:25 - Fail

drain system and attempt to repair  
and attempt fairs - the crack gets larger  
each time.

17:00 JLS will regroup and attempt to repair pipe  
Sunday AM,  
setup testing schedule w/ 14T1 - 6:00 AM

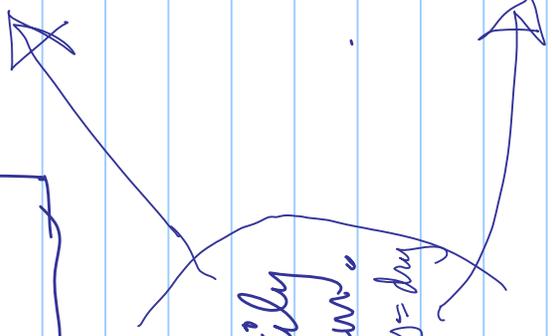
20  
+  
21  
JLS reports that the VMG on walls is easily removed with K&P vacuum. HTI tests moisture of walls = dry

JLS Seals Floor at 20 in chase  
21:15 Chase 24 detail cleaning completed - prep  
for testing w/ HTI (Chase in 24 sealed at floor)  
JLS will begin remediation of for bench 20  
" " open wall cavity " " 21

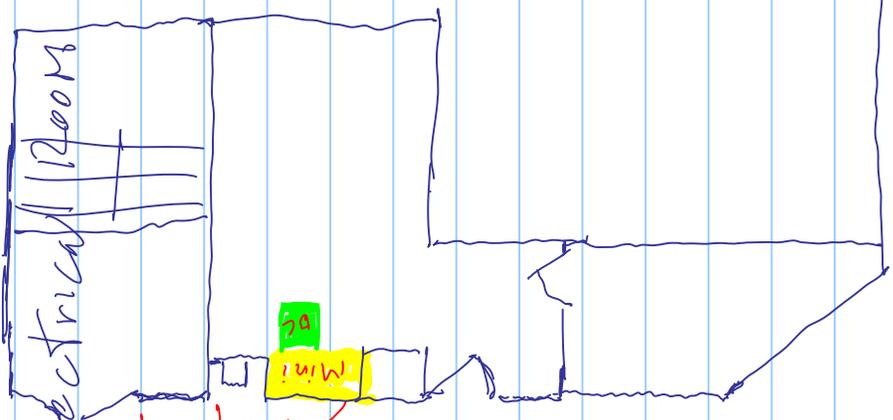
W. Electrical Room (at 1st fl)

Walls are plaster on metal lathe in these areas!

Plaster is disintegrating at some locations

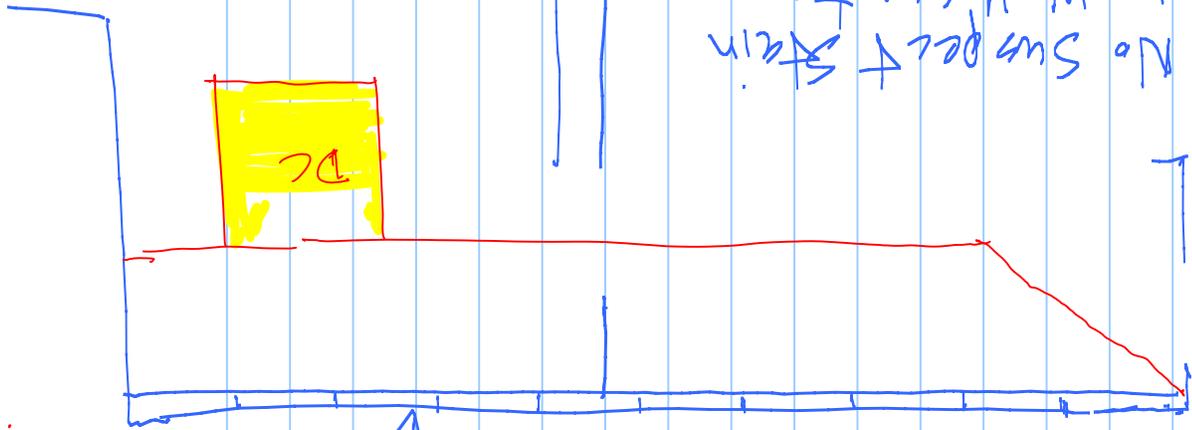
Floor 1 Electrical Room (

No Suspect Stain  
in Wall cavity  
a small rust stains at  
screws on removed  
section of GRB
